# Navajo Abandoned Uranium Mine Site Screen Report

## Section 18 SEQ AUM Site

### Navajo AUM Eastern Region

**May 2009**

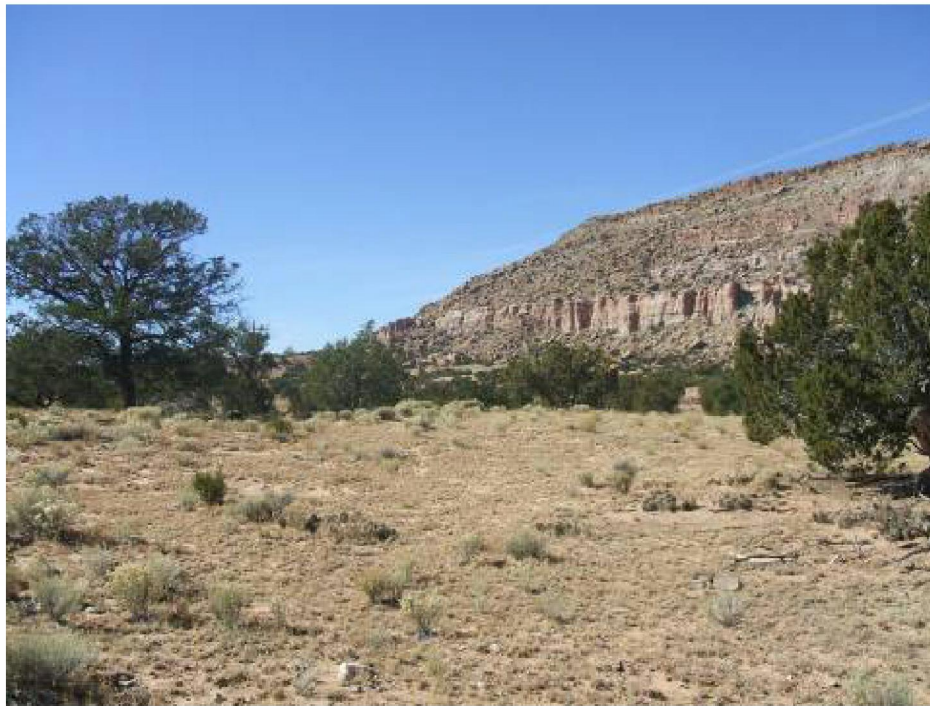
Reclamation status of the mine site is currently unknown. No waste pile, pits, adits or other mine features were observed during the site visit.

Photo 1. Section 18 SEQ mine site, towards the southwest

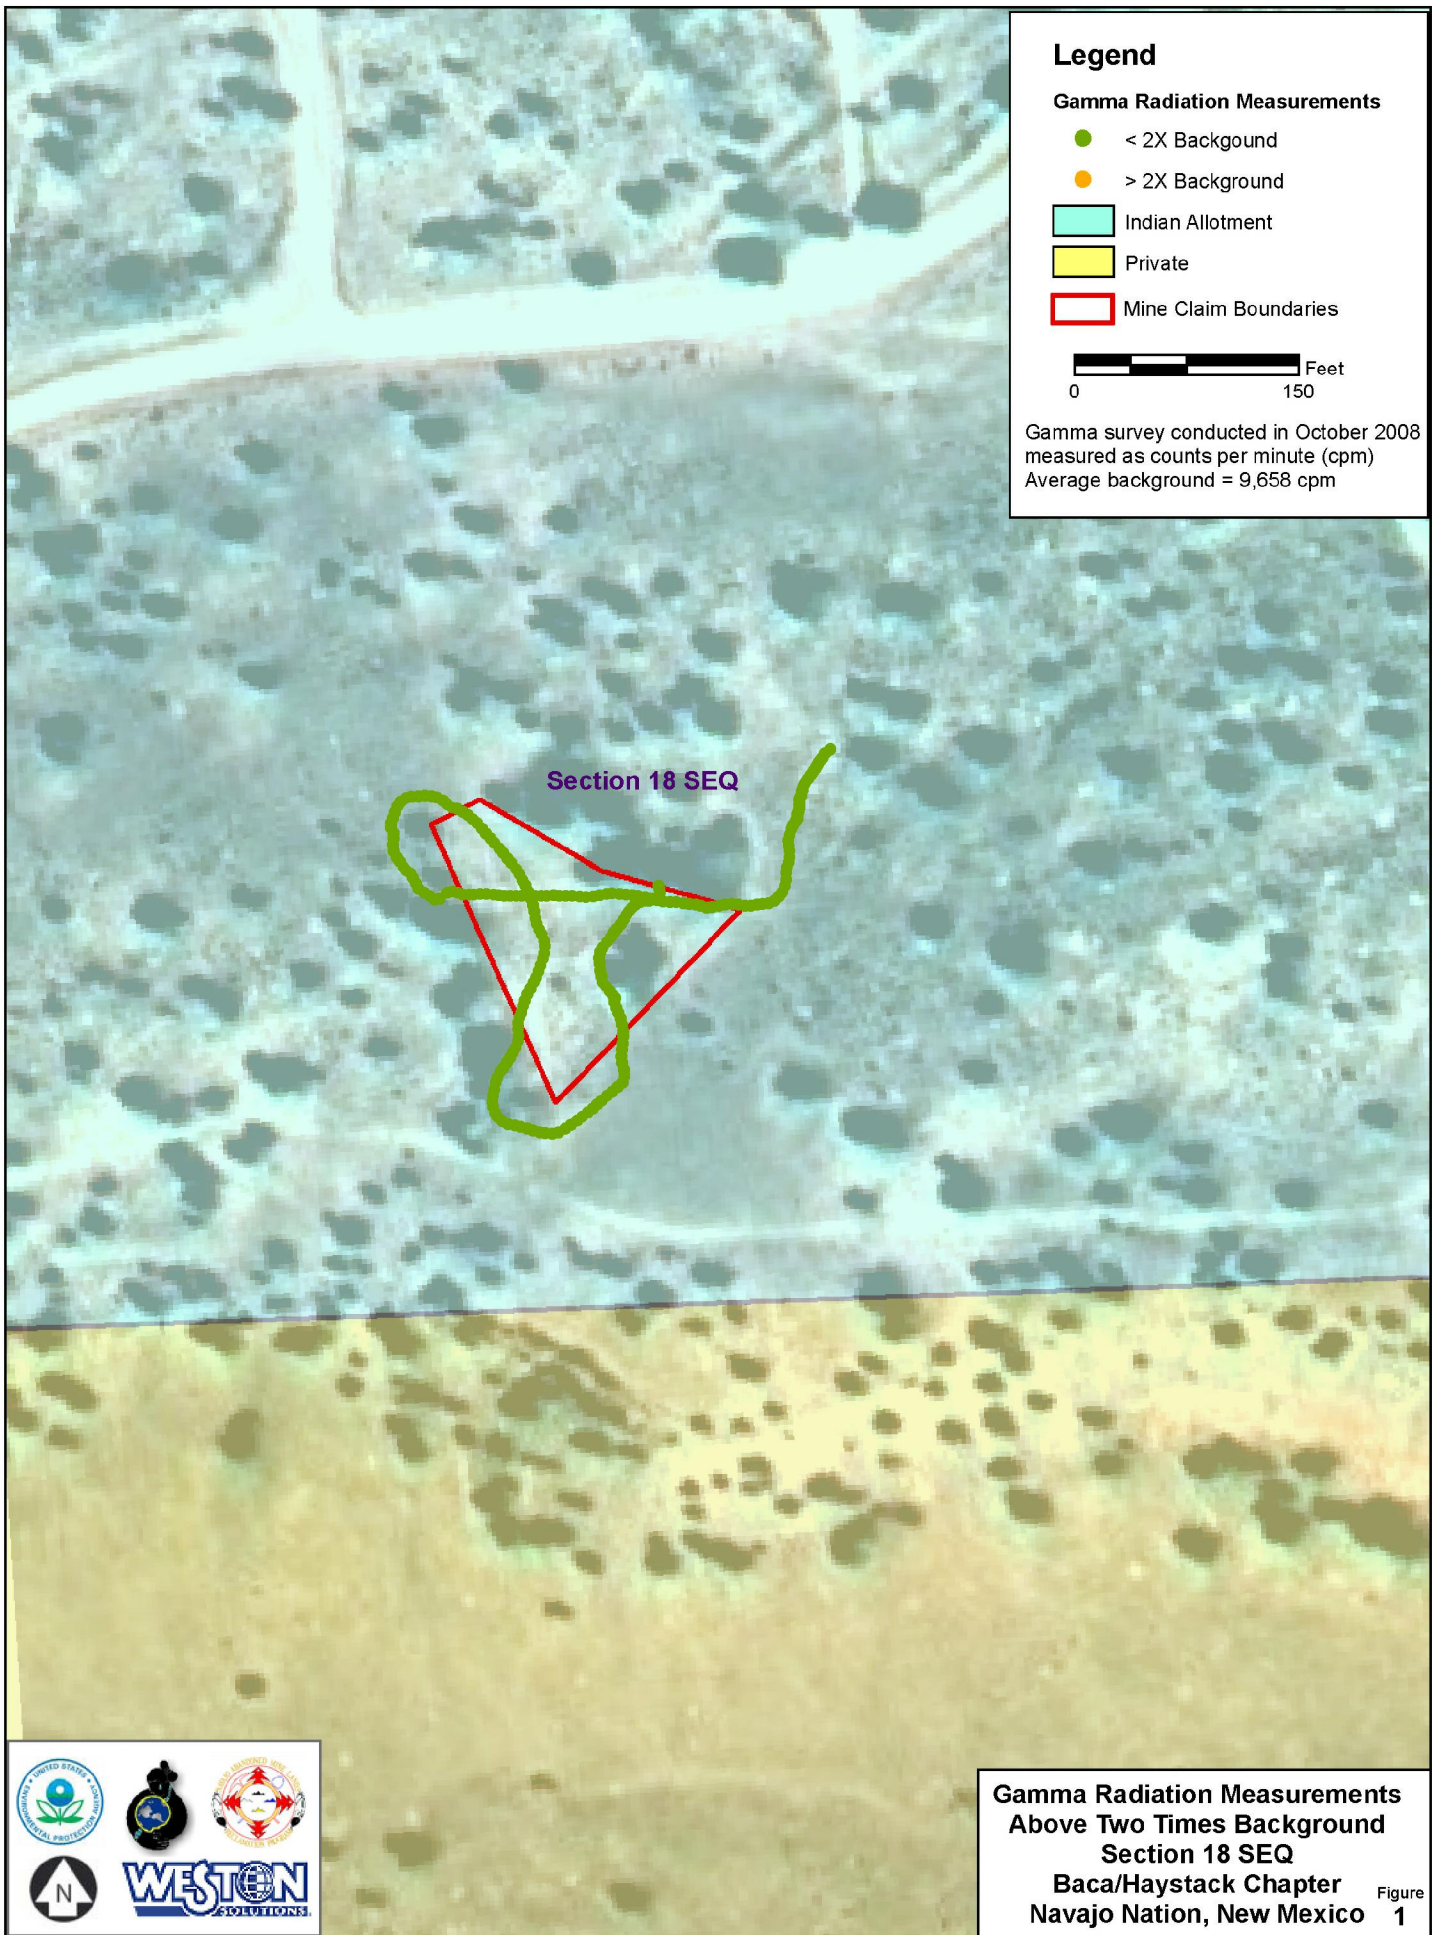
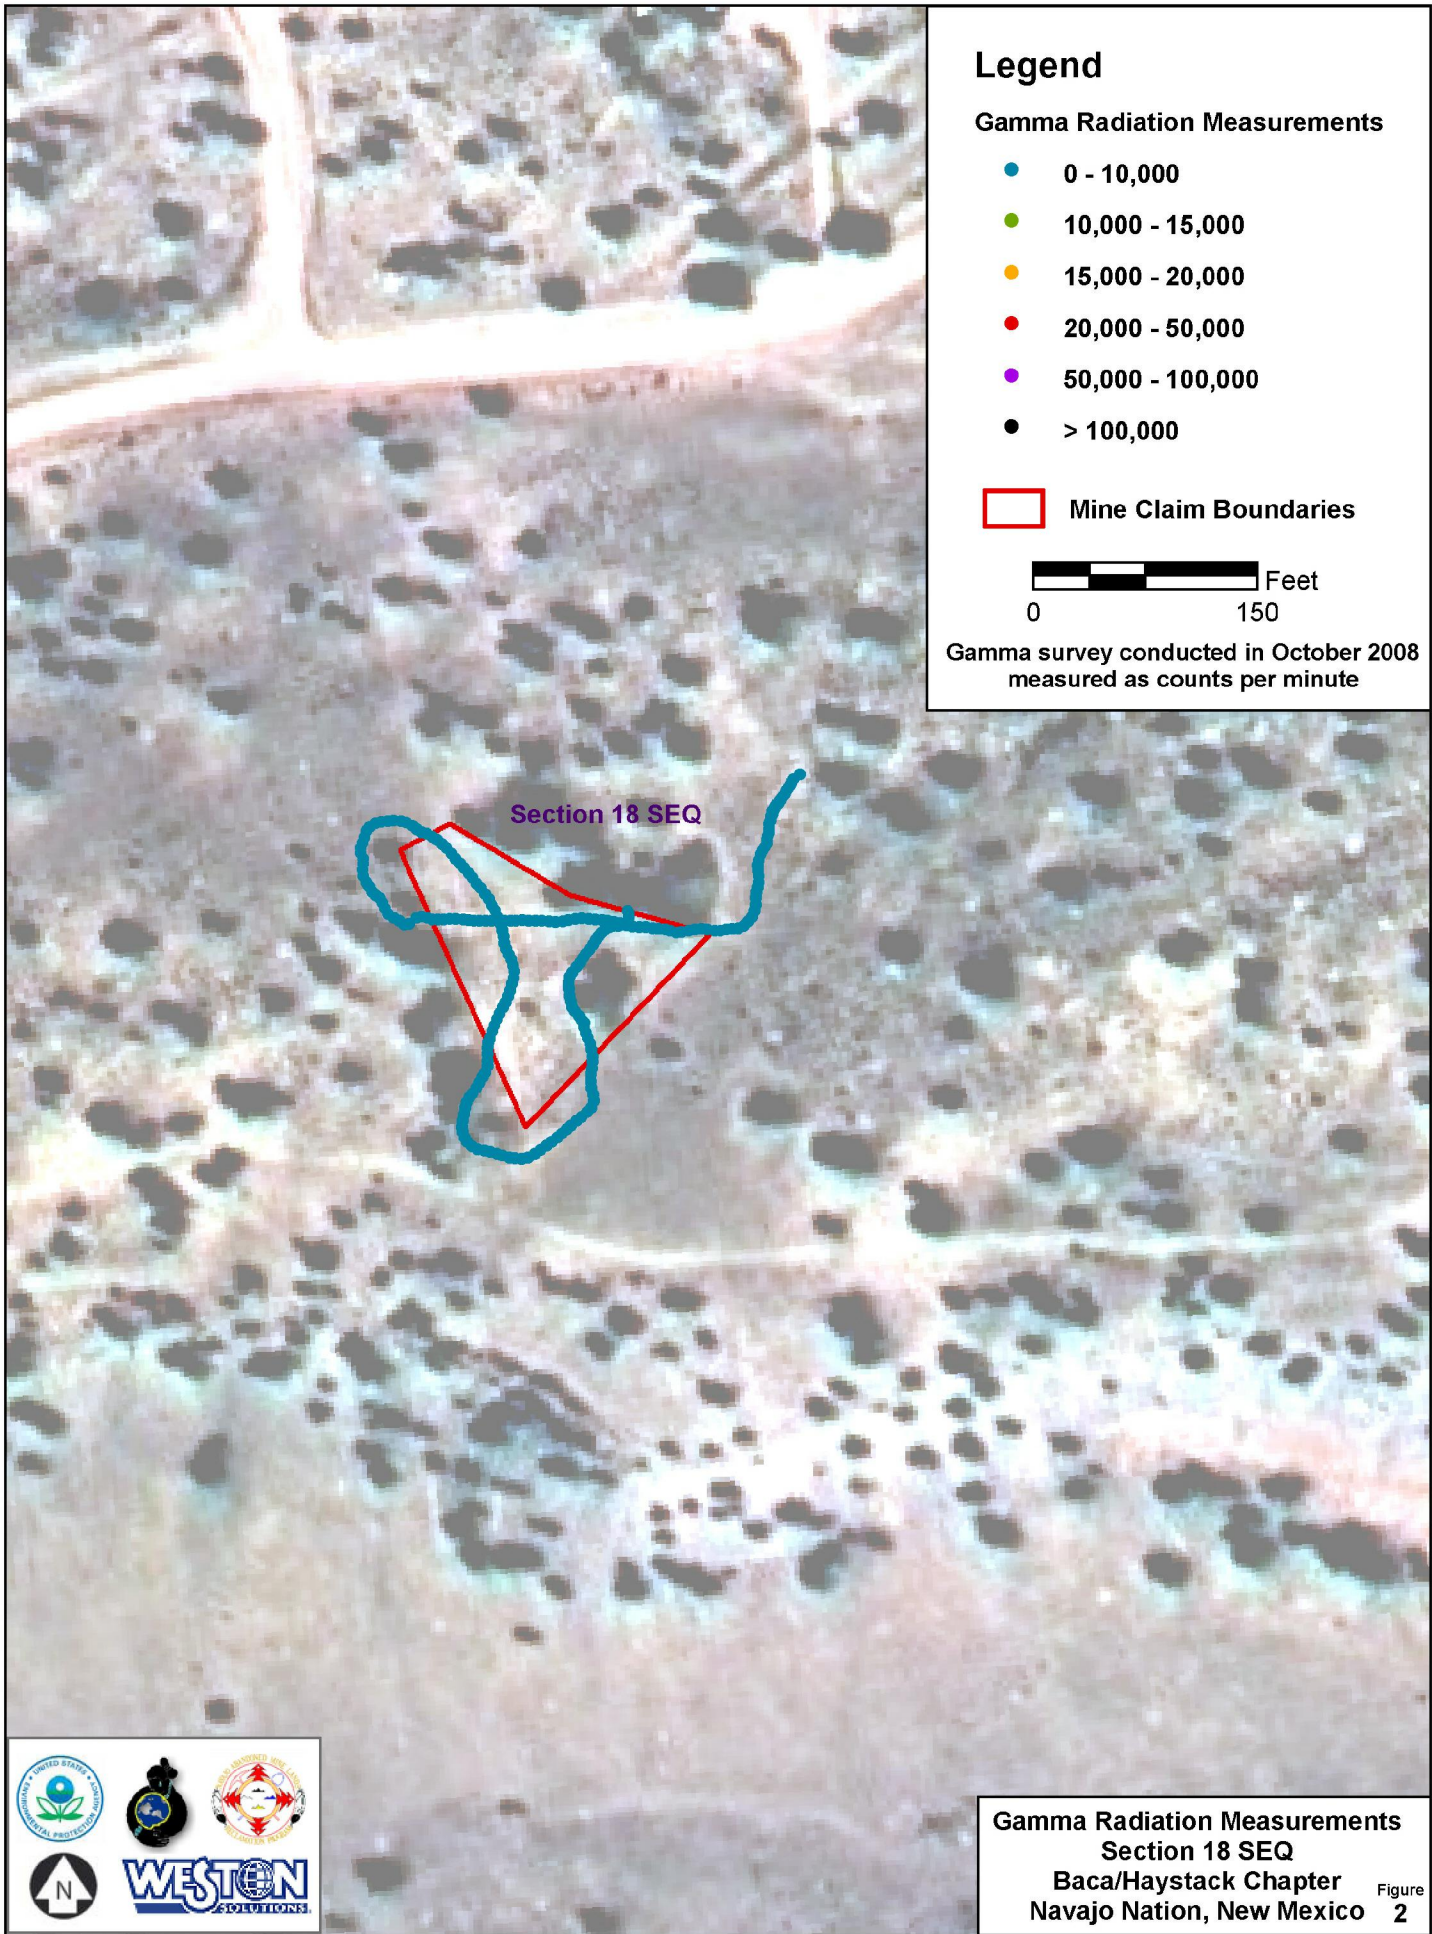
A total of 253 gamma radiation measurements were collected from mine sites, ranging from 6,469 cpm to 8,775 cpm. The measurements are represented in Figures 1 and 2.

Presented in Figures 1 and 2
